An Update on Bowstring Truss Issues

Paul C. Gilham, P.E., S.E., Chief Engineer, Western Wood Structures, Inc.
Brentley A. Matthias, P.E. Senior Project Engineer, Western Wood Structure, Inc.

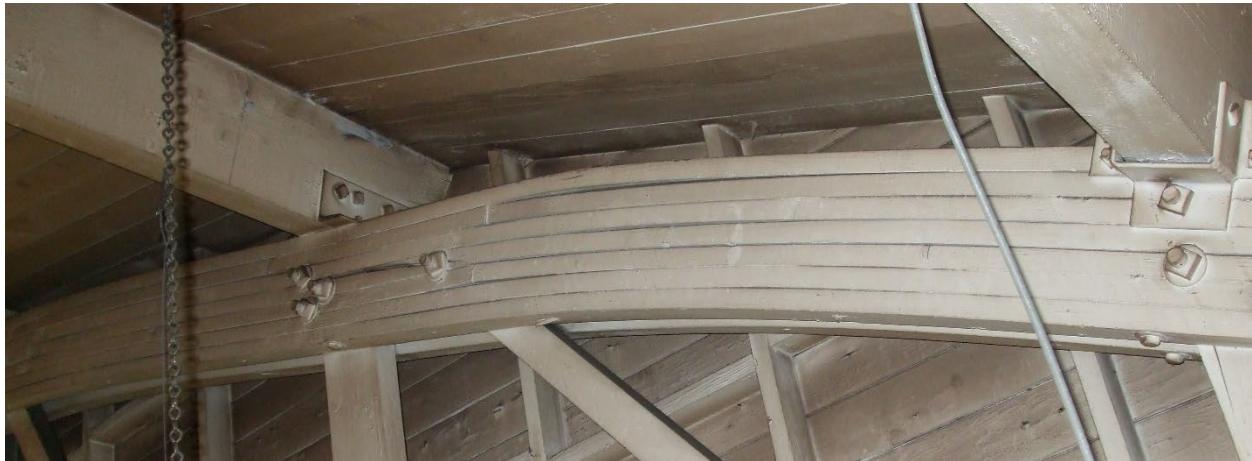
In trusses inspected by WWS, there is no evidence that the adhesive remains. A steel feeler gauge can be inserted completely through the chords between the laminations, much like a dry glue joint. A research note prepared by the Forest Products Laboratory indicated that to achieve a bond stronger than the wood itself, the laminations should be clamped under a pressure of 150 to 200 pounds per square inch. [3] The open face bonds indicate that the nailing did not provide enough pressure for the adhesive to form a permanent face bond. The nailing and bolting of the laminations alone are not adequate to achieve a composite section. Therefore, the section properties of the top chord are simply the sum of the cross sections for the individual laminations. See photo #2.

For example, the top chord in photo #2 uses (7) $1\frac{5}{8}'' \times 3\frac{5}{8}''$ laminations. With effective adhesive attaching all of these laminations, the moment of inertia (I) is 444.61 in^4 and the section modulus (S) is 78.17 in^3 . Without adhesive between the laminations, the moment of inertia is 9.07 in^4 and the section modulus is 11.17 in^3 . The bending strength in the section with no adhesive is seven times less than the section with an effective bond between laminations.

Photo #2. Top chord showing effects of adhesive deterioration

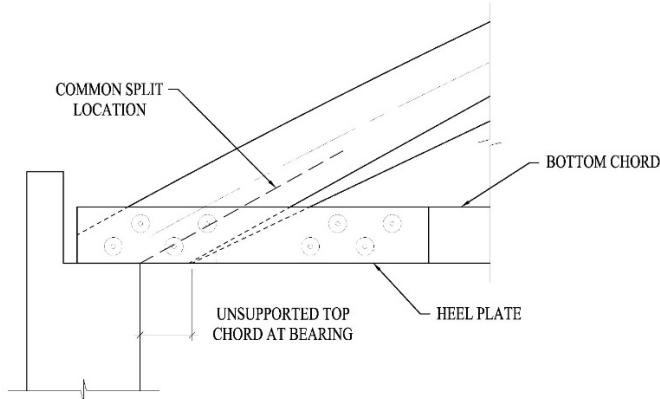
For the bearing condition shown in Figure 8, $d = 12.9"$ and $d_n = 9.1"$. The allowable shear capacity in the top chord is roughly 35% of the shear capacity of a fully supported member.

Figure 8. Unsupported top chord at bearing

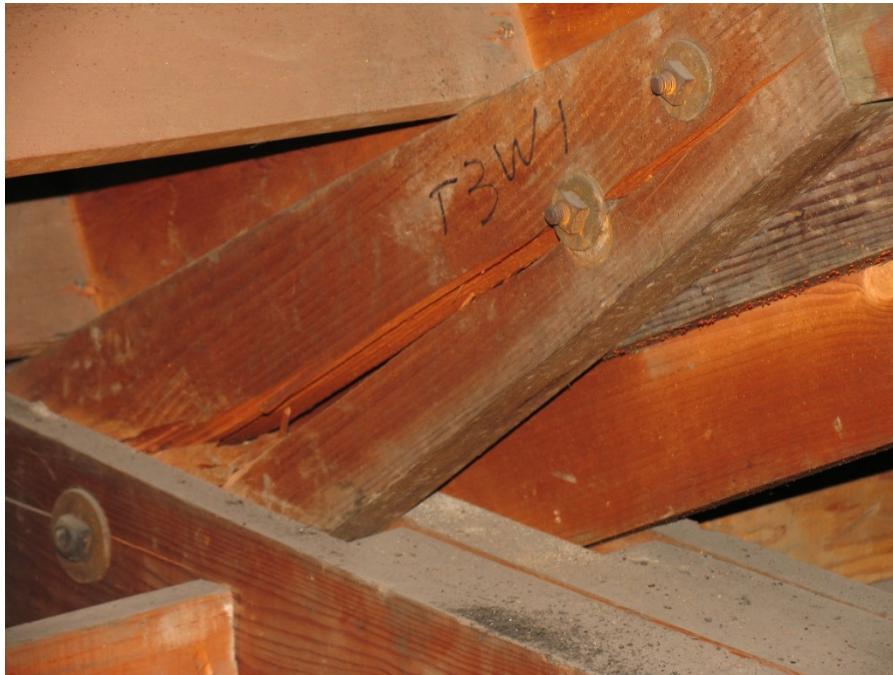
Except for the TECO truss, the heel assemblies of these trusses use a steel butt plate at the end of the top chord welded to steel side plates that were bolted to the bottom chord. With the TECO truss, wood side plates and a wood block connected the top chord to the bottom chord. These plates and blocks were connected using split rings. To provide the required end distance for the connectors, the top chord was cut horizontally on the soffit leaving a portion of the top chord unsupported at the bearing. See Figure 8. The top chords tend to split at the face of the bearing. This split can propagate up the top chord until at some point the top chord fails. (See photo #3) Often the bottom chord fails at the same time.

The unsupported portion of the top chord at the bearing acts as a beam notched on the tension face at the support. Using current design requirements contained in NDS section 3.4.3.2a, the shear capacity of a notched member is reduced as follows. [20]

Photo #3. Top Chord failure at truss heel.

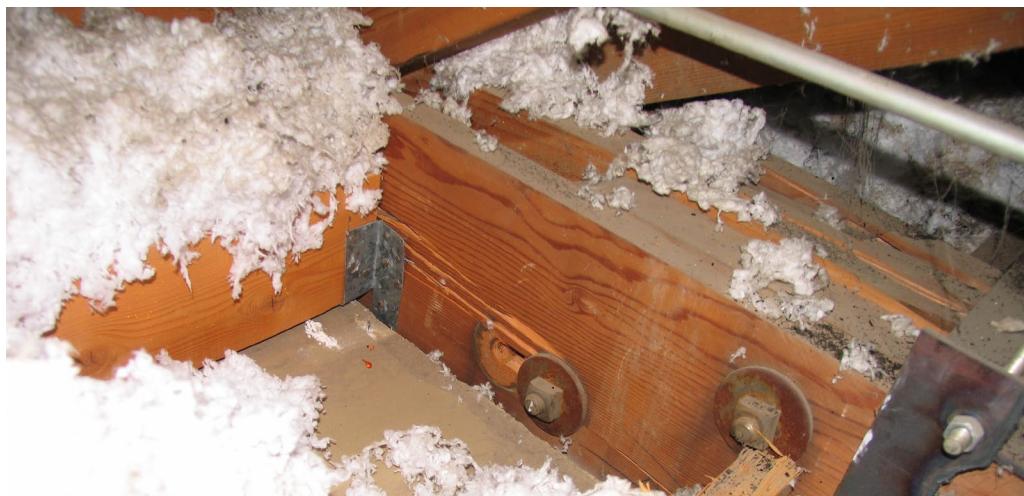
Clearly, the row tear-out capacity of such a joint is significantly less than the member or bolt capacity. Row tear-out failures are not uncommon. (See photos #4 and #5)

Photo #4. Row tear-out of bottom chord at splice connection.

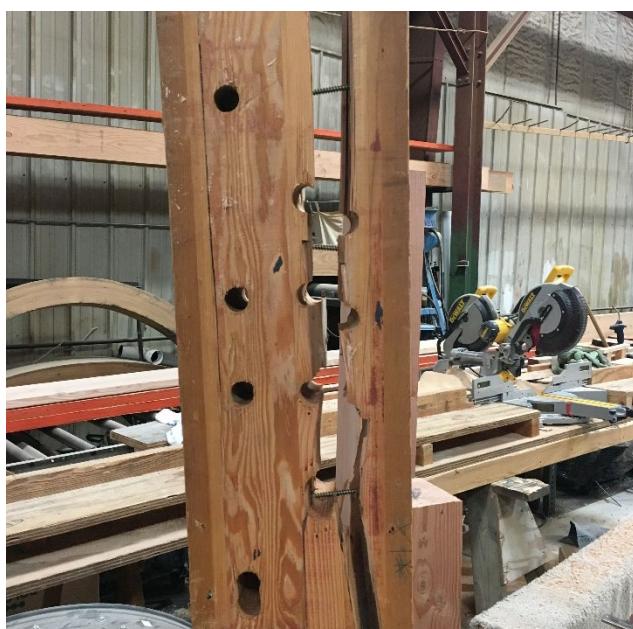
Photo #5. Group tear-out of truss bottom chord.

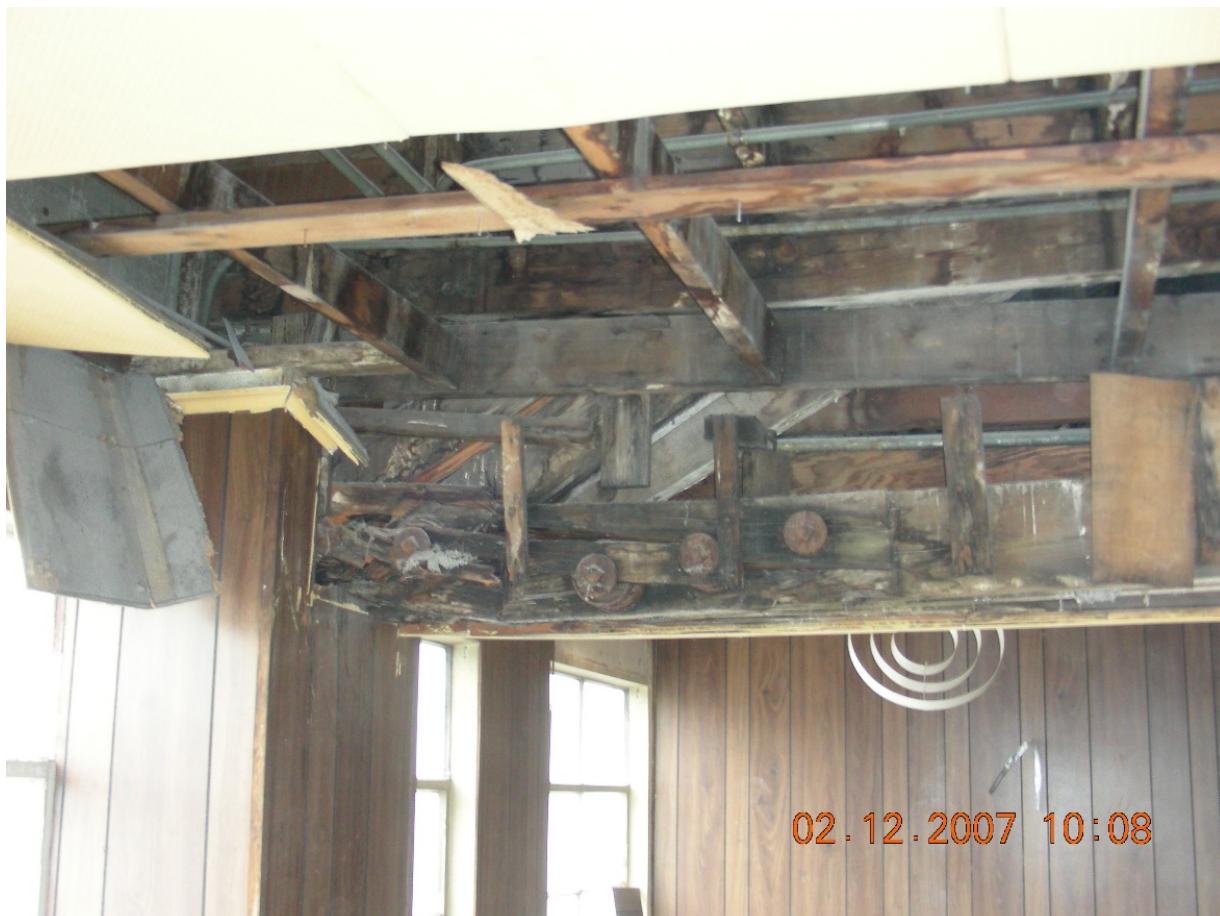
It is not uncommon to find significant water stains on trusses near the heels. Many buildings with parapets constrain the runoff of water from the roof. When the roof drains plug or the roofing fails, the truss heels are exposed to water. Long term exposure to water will lead to decay and degradation of the truss members. Water intrusion issues can be detected by water staining on the truss members. If decay is suspected, non-destructive inspection techniques such as boring the members with a resistograph can be used to determine the extent of damage.

Photo #6 Decayed heel caused by poor roof drainage Note the water staining on the members.

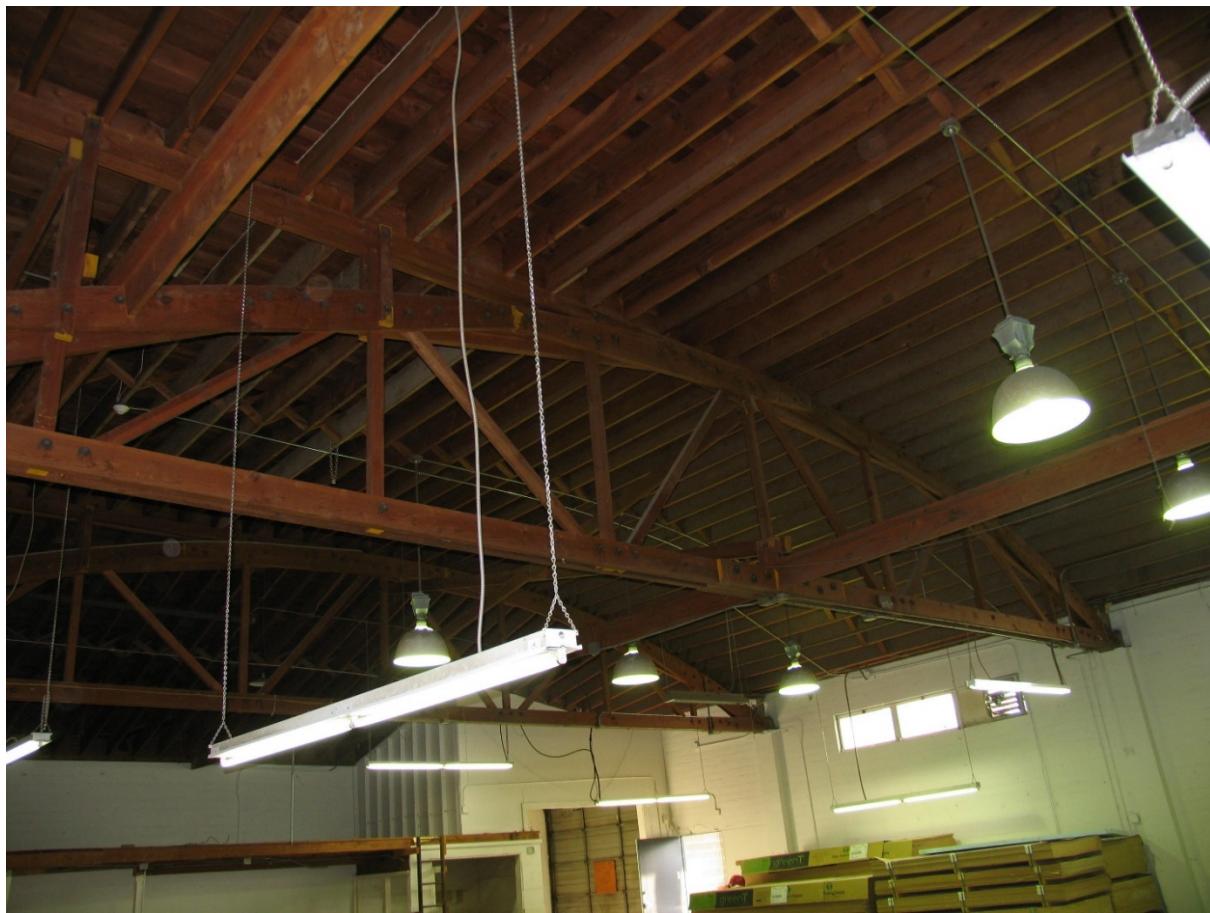
Often one or more trusses are positioned end to end and the valley between the trusses is over-framed to form a flat roof. In photo #7 below, the left side of the truss is over-framed to form a flat roof. The roof “beam” is supported by the vertical truss webs that are extended to the roof. When this roof configuration is used, the top chord below the over-framing is unsupported laterally between the vertical webs. The top chords for a full bowstring truss typically have roof joists attached at 2'-0" on center and the L/d ratio for the chord is 9.6. With the over-framing, the L/d ratio increases to 30 with vertical web spacing at 6'-3" on center. C_p drops from 0.92 for the standard configuration to 0.28 for the over-framed condition. With this reduction in C_p and allowable load capacity, many top chords become overstressed and need to be stiffened.

This roof configuration significantly changes the way that the loads are applied and resisted by the trusses. For the truss in photo 7, under dead load plus balanced snow load, the moment in the top chord at the first vertical web increases from 11,647.62 psi. on the right side of the truss to 22,256.23 psi on the left side. This increase in bending stress and the decrease in axial load capacity resulted in an increase from 0.6612 to 1.3768 in the interaction formula for combined bending and axial load. The loads in the bottom chord are significantly increased in the overframed area. The roof beam is supported by the vertical web and the axial force in the web is resisted by both the top and bottom chord. This usually results in large moments in the bottom chord. The analysis of these members indicates high shear forces in the vertical webs.

Photo #7. Truss with over-framing on one side.
