An Update on Bowstring Truss Issues

Paul C. Gilham, P.E., S.E., Chief Engineer, Western Wood Structures, Inc.
Brentley A. Matthias, P.E. Senior Project Engineer, Western Wood Structure, Inc.

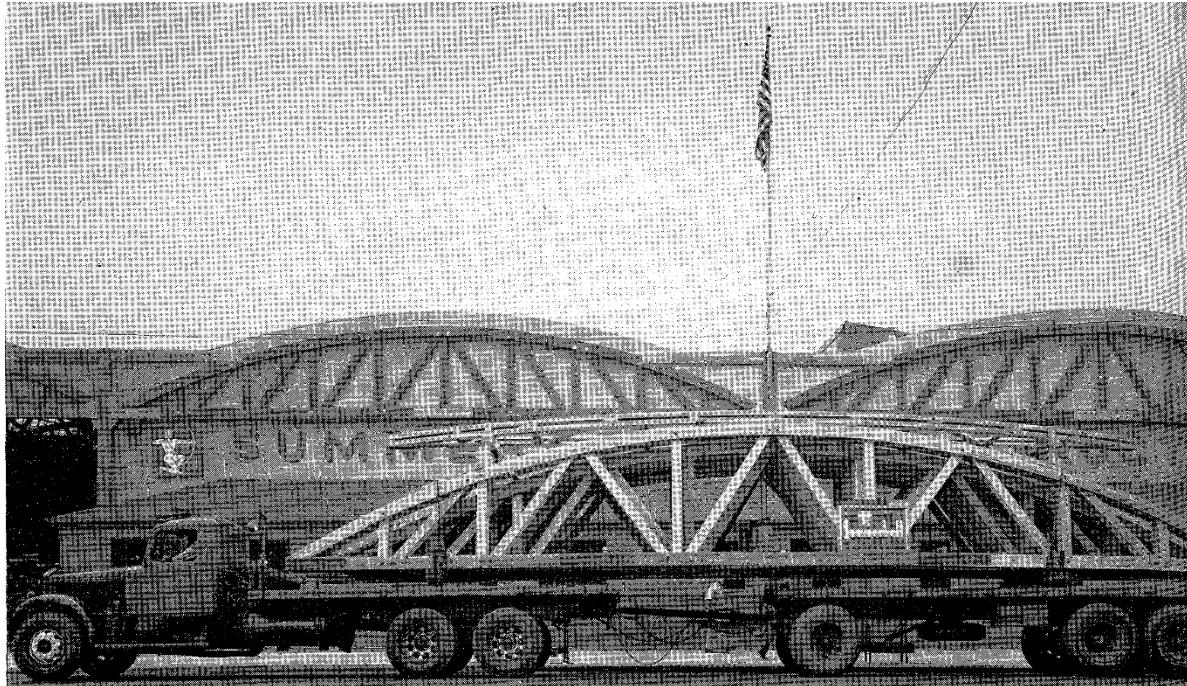
Photo #1. "Summerbell Trusses" leaving the plant toward a new structure

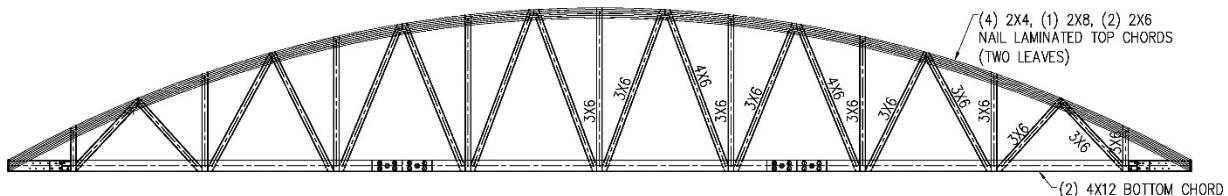
Figure 1. Example of a "Summerbell" Truss.

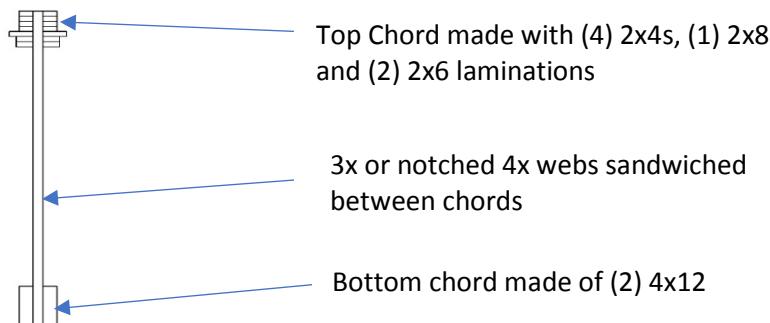
Figure 2. Cross Section of "Summerbell" Truss shown in figure 1.

For example, the top chord in photo #2 uses (7) $1\frac{5}{8}'' \times 3\frac{5}{8}''$ laminations. With effective adhesive attaching all of these laminations, the moment of inertia (I) is 444.61 in^4 and the section modulus (S) is 78.17 in^3 . Without adhesive between the laminations, the moment of inertia is 9.07 in^4 and the section modulus is 11.17 in^3 . The bending strength in the section with no adhesive is seven times less than the section with an effective bond between laminations.

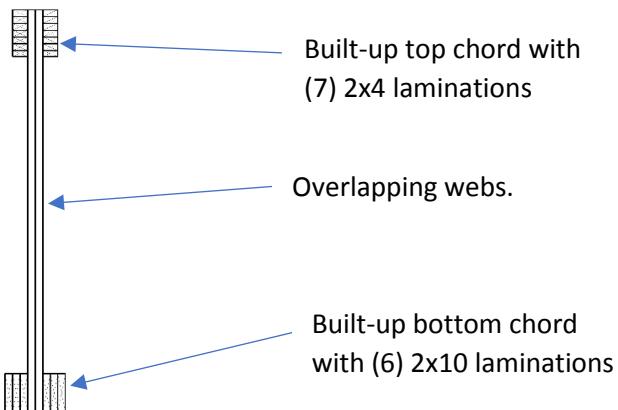
Figure 4. Lattice Truss Section of truss shown in figure 3.

Top chords are made with laminated 2x members, oriented horizontally. The curve is established by bolting the bottom lamination to the webs. The remaining laminations are nailed together with a series of 40d, 20d and 16d nails. The chords are attached to the lattice webs with (2) rows of $\frac{1}{2}$ " diameter machine bolts in each lattice member. The bottom chords consist of two runs of three 2x members oriented vertically on each side of the lattice webs. These members have staggered splices such that two members in each run are effective at any section. The webs are single 2x members, nailed together with (4) 16d nails at each intersection.

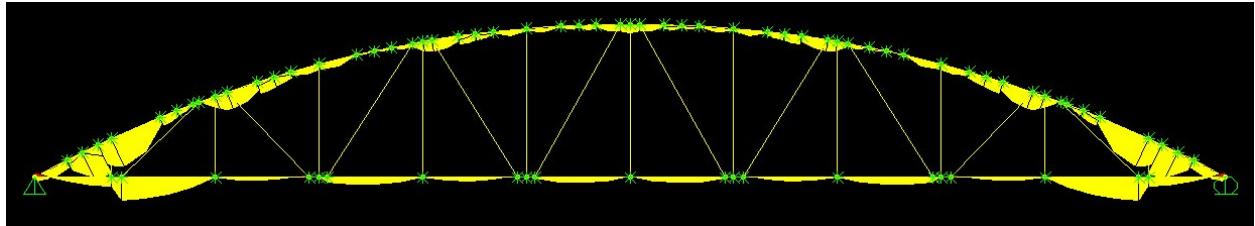
The original technique used to determine the member forces for these trusses was a graphical method that used classical truss analysis methods. With the classical method, the members are pinned at each joint and the loads were applied at the joints. This method was only able to determine the axial forces in the members. It did not yield any bending moments or shear forces. Some designers applied a bending moment to the top chord based on the three-beam equation and added an additional bending moment to the top chord by multiplying the axial force by the eccentricity caused by the curvature of the roof. [11] These analysis methods did not adequately account for member continuity over a joint, the eccentric placement of web to chord connections or the secondary moments caused by deformations. To capture all the forces applied to the truss members these trusses should be modeled using frame analysis software. By computer modeling the truss, including the effects of member continuity at the joints, the eccentricity of the web to chord joints, the curvature of the top chord and non-prismatic sections at the top chord, more exact member forces can be determined. The analysis results often yield large moments in the top and bottom chords at the first vertical web. These members can then be checked for combined bending and axial stresses using the provisions of the National Design Specification for Wood Construction [12] (NDS) The addition of the bending stresses at the joint often causes a substantially overstressed condition in the top chord and bottom chord at the first joint, which is often the location of the first failure in the truss. See Figure 5

Figure 5. Moment diagram of truss modeled with actual member continuity and eccentric web connections.

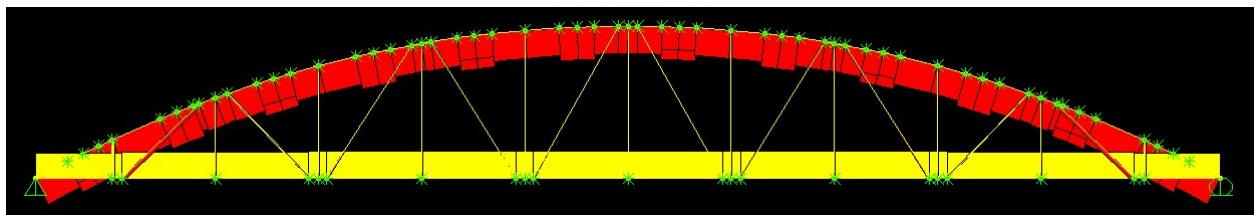
Figure 6. Axial loads under balanced dead load plus snow load. All webs except the first diagonal web are stressed in tension.

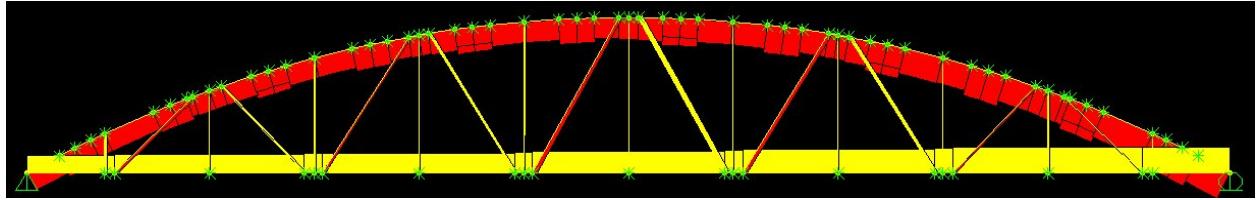
Before the unbalanced load requirement, these trusses were designed such that most of the webs would be in tension. Webs stressed in compression were usually wider to reduce the L/d ratio. When an unbalanced load is applied, the forces in many of the webs change from tension to compression. The strength of the longer web members is governed by the L/d ratio. Many of these webs have an L/d ratio greater than 50 which is not allowed by the NDS.

Figure 7. Axial loads under dead load plus unbalanced snow load on right hand side. Webs with red highlight are stressed in compression. Webs reverse sign when unbalanced snow is on the left.
